**LAKE HERITAGE PROPERTY OWNER DAM
(LAKE HERITAGE)**

**PHASE I INSPECTION REPORT
NATIONAL DAM SAFETY PROGRAM**

NDI NO. PA 334

Lake Heritage Property Owners Dam
Pennsylvania
Adams County
Plum Run
April 5 & 6, 1978
Inspection Team - EADS

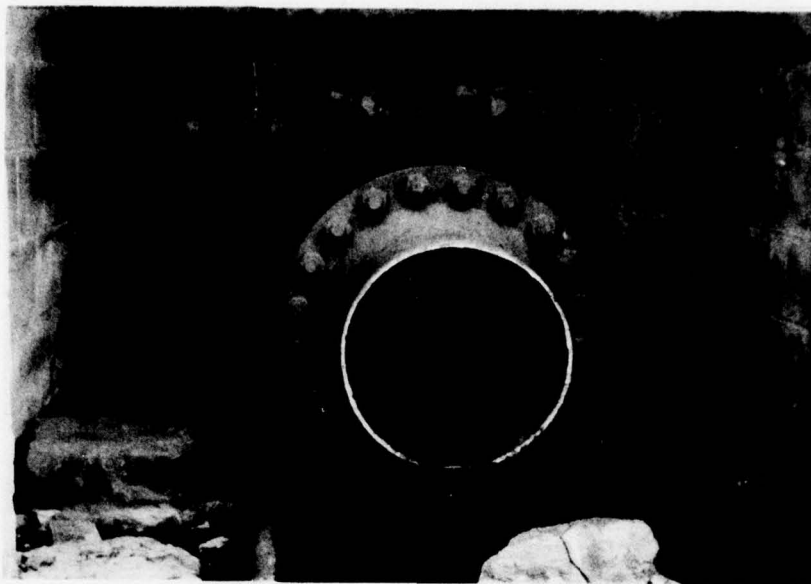
DOWNSTREAM END OF OUTLET PIPE, SHOWING
15" DISCHARGE PIPE & 16" PLUG VALVE DOWNSTREAM
FROM 24" GATE VALVE

1. The Owner retain a competent engineer to make an hydrologic and hydraulic analysis of Lake Heritage to determine the capacity of the spillway and the frequency of flood that the dam can pass without overtopping. The study should also consider and make recommendations for decreasing the overtopping potential of the dam, as well as develop a rating curve for the outlet pipe due to the plug valve being installed downstream from the gate valve.

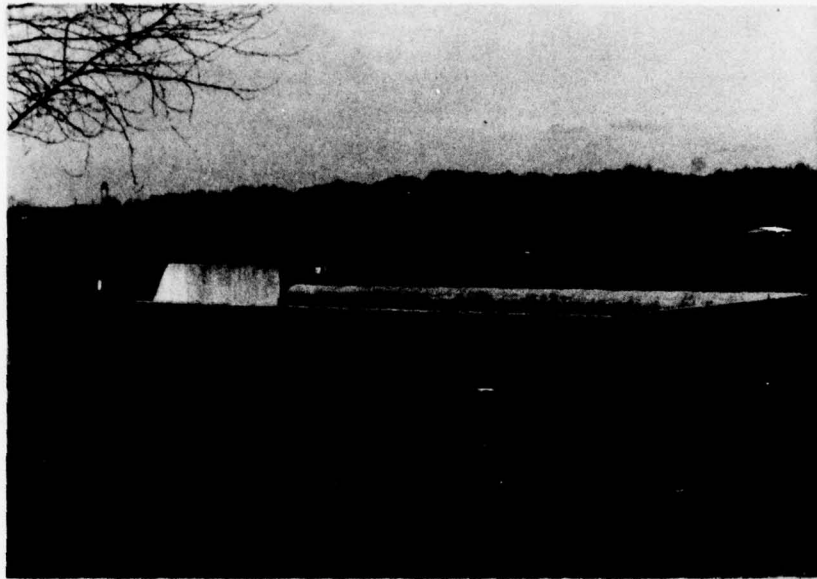
VIEW OF DAM SPILLWAY, LOOKING SOUTHWEST
